361TS, 361DTS Tub Spout Series

Operation & Maintenance Manual

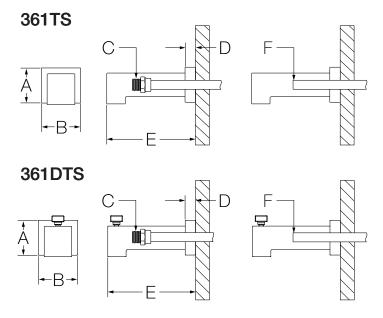
Dimensions

Measurements			
Α	2-1/4", 57 mm		
В	2-1/2", 64 mm		
С	Male 1/2-14 NPT fitting		
	must protrude		
	3-7/8" (98 mm)		
	from finished wall		
D	5/8", 16 mm		
Е	5-5/8", 143 mm		
F	1/2" rigid copper tubing		
	must protrude		
	Min. 1-3/4" (44 mm)		
	Max. 2-3/4" (70 mm)		
	from finished wall

1) Male 1/2-14 NPT fitting must protrude 3-7/8" (98 mm) from finished wall

1) Rigid copper tubing must protrude 1-3/4" (44 mm) - 2-3/4" (70 mm) from finished wall.
